# Landslide Dams Caused by the November 14, 2016, M7.8 Kaikoura Earthquake, New Zealand

Brenda ROSSER<sup>1\*</sup>, Chris MASSEY<sup>1</sup>, Sally DELLOW<sup>1</sup>, Simon COX<sup>2</sup>

<sup>1</sup>GNS Science, Lower Hutt, New Zealand

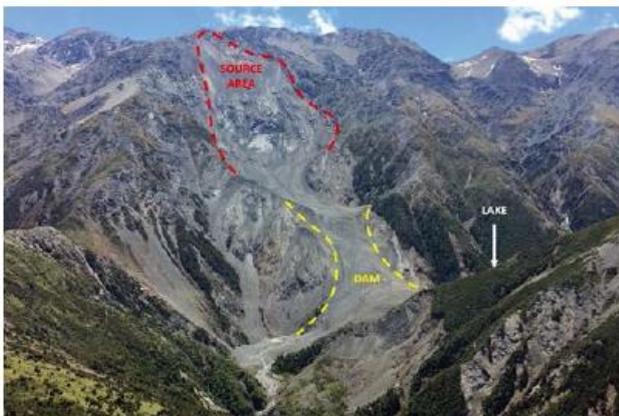
Hapuku landslide dam: about 20 million cubic metres of rock travelled 2.7 km to the valley floor, blocking the Hapuku River.

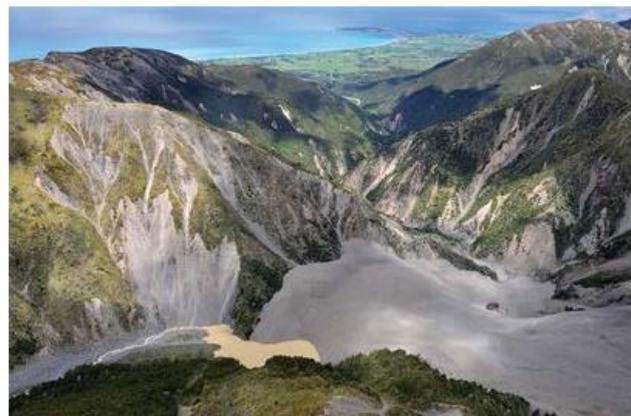
Hapuku landslide dam, showing the deposit and lake forming upstream (photo: Environment Canterbury).

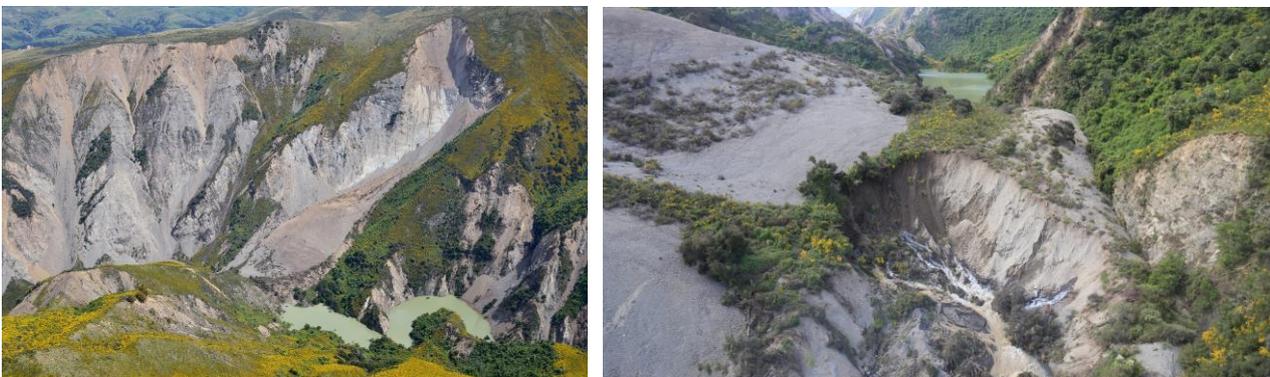
Landslide dam on the Conway River (a) two days following the Kaikoura earthquake, and (b) one week following the earthquake. The landslide dam failed due to a combination of seepage and headward erosion through the landslide deposit.
