Assessment of Landslide Recurrence by Onsite Monitoring - Incidence of Hung-Yeh Landslide -

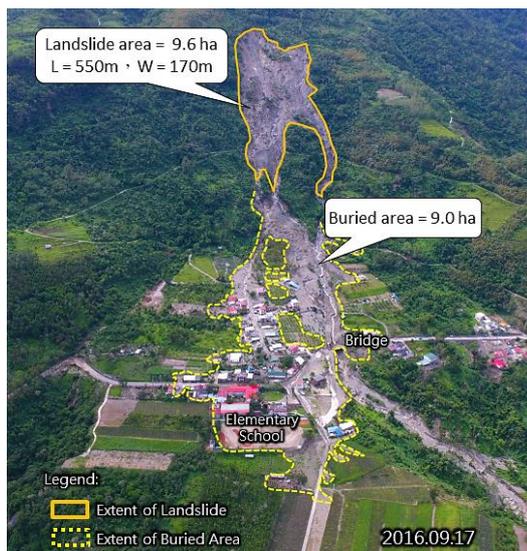
Typhoon Meranti brought 651.5 mm of rain in four days to Hung-Yeh Village in Taitung County, Taiwan starting from September 12, 2016, which triggered a 7.8-ha landslide with approximate volume of 40,000 m³ of debris that damaged 39 housings, 3 public buildings, and local traffic system (**Fig. 1**).

Fig. 1 Disaster caused by September 12 2016 landslide

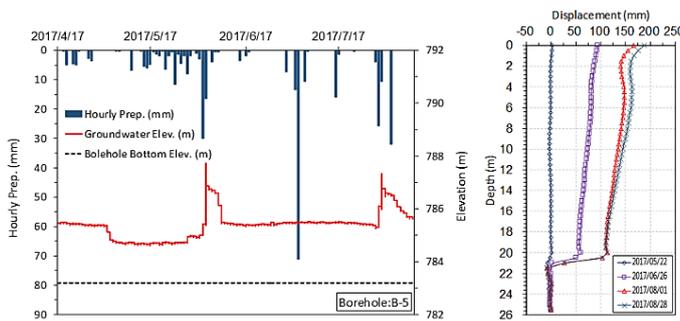
Fig. 2 Groundwater elevation readings from B-5

Results from groundwater-elevation readings indicated groundwater levels changed rapidly and synchronized with rainfall particularly for B-2, B-3, and B-5 that constituted the entire landslide scarp section. Core samples taken from these boreholes also indicated the existence of rock fractures. Inclinator readings from B-5 (**Fig. 2**) showed a 18.8-cm displacement in downslope direction in three months.

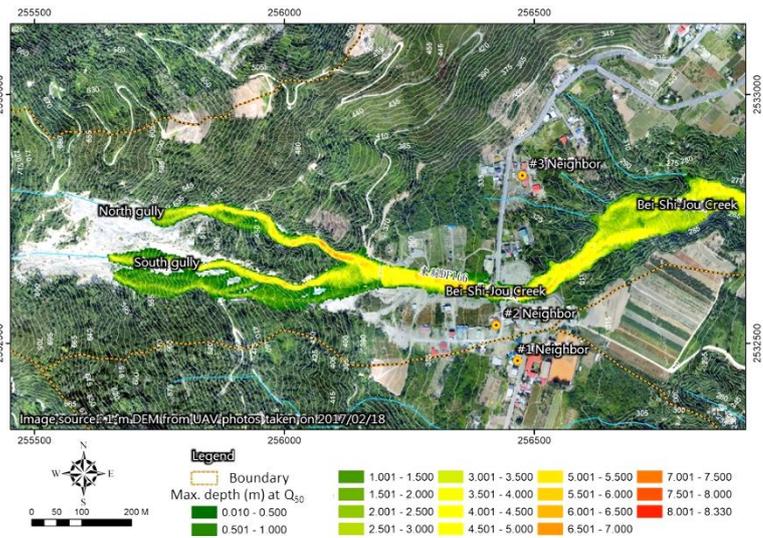
Numerical simulation assessment of debris-flow affecting areas at different rainfall scenarios is still undertaken while gully control and check dam construction continuously alters the landslide landscape. It will provide update information to both government agency and construction company when refinement of restoration project is needed.

Fig. 3 Numerical simulation of debris-flow affecting
