Extreme Torrential Flooding at Simbach on June 1st, 2016 - Findings of a Detailed Event Analysis -

Andreas RIMBOECK^{1*} and Johannes HUEBL²

¹ Bavarian Environment Agency, Augsburg, Germany

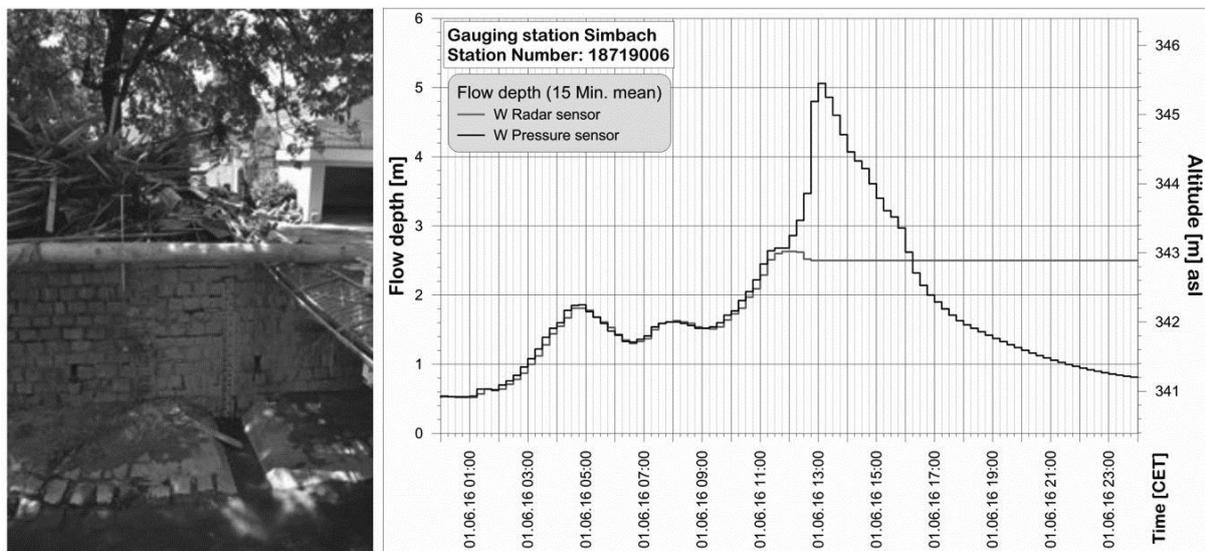
The first objective of the detailed analysis (Hübl, et al. 2017) was to reconstruct the triggering rainfall and the maximum discharge during the event. The high complexity of this extreme event needed high effort, e.g. 838 photos and 62 videos were analysed. Although the water gauge (**Fig. 1**) recorded the water level far above its area of validity, the data can only be considered as a rough approximation for the real discharge. Therefore different approaches were used to identify the “real” discharge:

Fig. 1 Situation at the gauging station short time after the flood event and the recorded water level

The analysis estimated the maximum discharge of about 280 -300 m³/s at the gauging station using a newly developed rating curve, comparing 1D and 2D hydraulic simulation results.

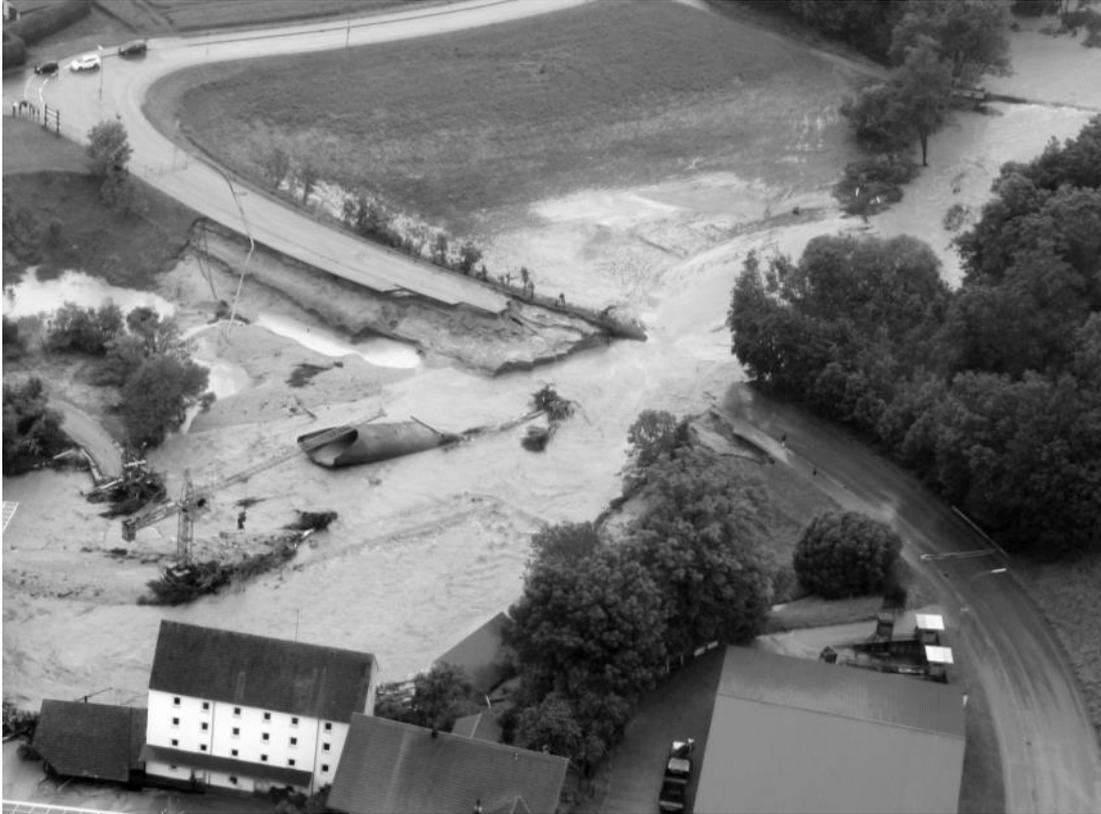
The second objective was to identify the effect of the dam failure in the upstream area (**Fig. 2**) and the dyke failure within the town of Simbach. Therefore the failures of the street dam and the dyke had to be implemented into a hydraulic model. As input Hydrograph, the “natural” discharge of the catchment was used. Subsequently different hydraulic scenarios, applying different dam failure characteristics were calculated, including the preceding partial blockage of the dam culvert.

Fig. 2 Situation at the street dam during failure process (Polizeipräsidium Niederbayern)

Dam breaching resulted in an increase of the discharge of about 120 m³/s immediately downstream of the failed dam and diminished along the channel downstream to the gauging site. To check this estimate the dam failure was implemented in two 2D-hydraulic models. The resulting inundation zone and flow depths were crosschecked with flow marks, pictures etc. to trace the discharge through the town.

The flooded area was not considerable enlarged by the breaching hydrograph, but the mean flow depth increased about 0.5 m in the town.
