# Countermeasure for Landslides along the Pan-American Highway in the Metropolitan Area of El Salvador - Countermeasures for Problem Soils of Paleosol Overlaying Erodible Glassy Pyroclastic Flows which Occurred in the Fifth-sixth Centuries -

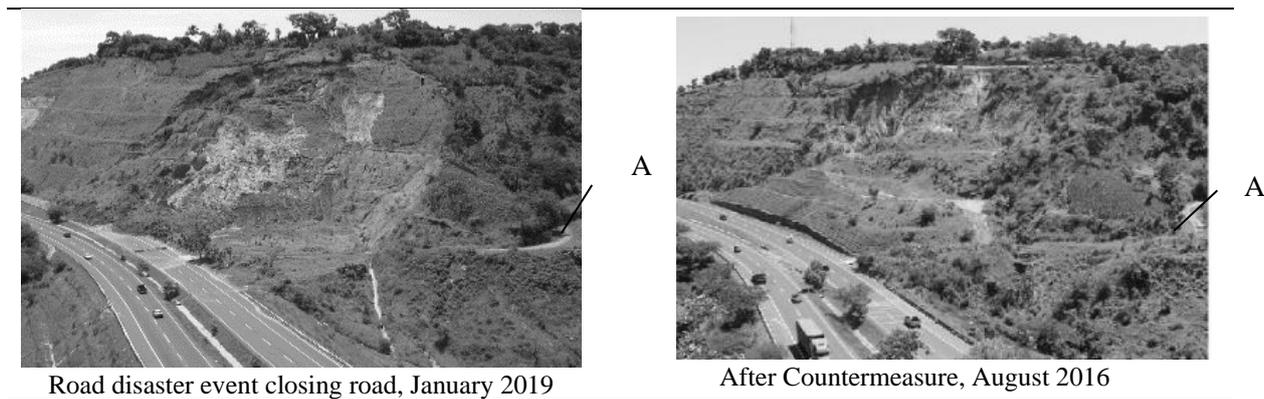
A landslide blocked 2 of the four lanes of the Pan-American Highway bypass in the Metropolitan Area of El Salvador on 15th January 2009. After removing the soil from the carriageway, the highway had been operating with only 3.5 lanes, resulting in traffic jams.

During the May-October 2012 rainy season, the landslide was reactivated with a peak speed of about 8cm per day based on control point movement. The landslide are approximately 65m height, 140m length, 120m width, and 130 thousand m<sup>3</sup> volume. The main portion of the sliding surface was about 10m deep from the top using pipe strain gauge detection. The landslide had clear scarp and cracks on flank and foot areas, so much so that the outline of the landslide was easily recognizable.

**Fig. 1** Disaster Event and After the Completion of the Countermeasures

Low cost general countermeasures were implemented in 2015 including earthworks (removal and filling), gabion retention walls with geocomposite drainage sheet and pipe drainage at the bottom of the gabion mountainside edge of road extension direction, concreting pavement of the community road on the landslide head, shotcrete works on the landslide scarp, drainage works (gutters),

underground drainage works (a total of 930m perforated plastic horizontal pipes, 10 drilling holes), and vetiver grass vegetation on the sliding mass surface for anti-erosion.
