Study on Driftwoods that Flow along with Debris Flow and Control by Closed-type Check Dam - Case of Iwaizumi-cho, Iwate Prefecture Sediment-related Disaster Caused by Typhoon No.10 (Lionrock) in 2016 -

Chie KUROIWA^{1*}, Naoki FUJIMURA² and Hideaki MIZUNO³

¹ Asia Air Survey Co., Ltd., Japan

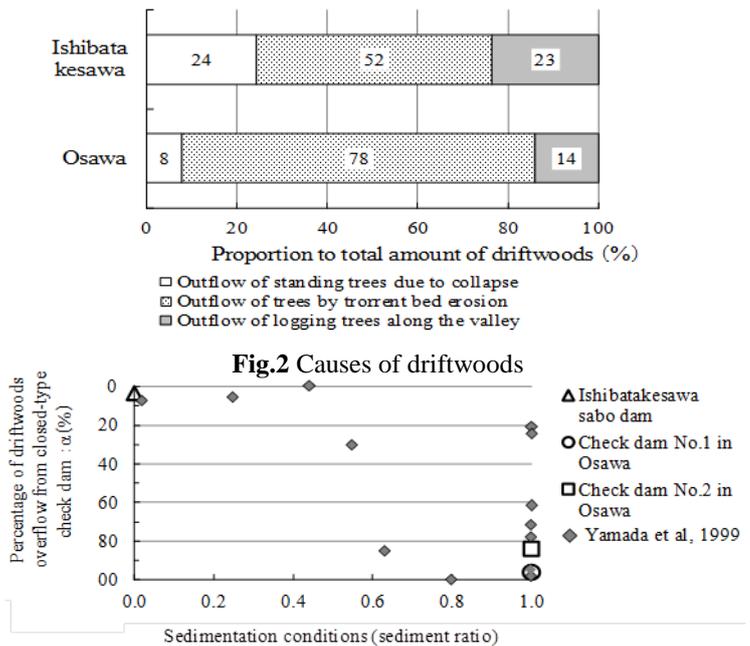
Fig.3 Relationship of sediment ratio and α

Fig. 3 shows the relationship between sedimentation conditions (sediment ratio) before the disaster and percentage of driftwoods overflow from closed-type check dam (α (%)).

Two dams in Osawa basin are in the full sedimentation (sediment ratio: 1) is also higher than the past record of full sedimentation (it was 80% more). In Osawa basin, as mentioned above, the driftwood flowing out to the check dam is mainly composed of relatively short length driftwood, and driftwoods do not close with spillway. On the other hand, α of the Ishibatakesawa basin (sediment ratio: 0) tend to be somewhat lower than the past record. The outflow discharge is not as large as it flowed beyond spillway and the driftwood is stored in a floating state on the flooded surface of the back of the weir in Ishibatakesawa basin.
