Geologic and Topographic Features of Slope Failure Sites in the Aso Caldera Wall Induced by the 2016 Kumamoto Earthquake

Haruka SAITOU^{1*}, Shin'ya KATSURA², Ryota UMETANI¹,
Mio KASAI² and Tomomi MARUTANI²

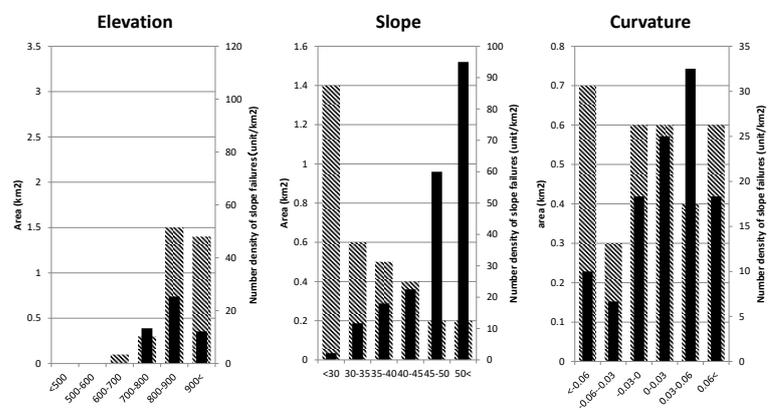
Fig. 2 Slope failure density for each class of elevation, slope, and curvature in the pyroclastic flow deposits

The slope failure density for each class of elevation, slope, and curvature was calculated for the pyroclastic flow deposits, which showed the largest slope failure density, as shown in **Fig. 2**. The slope failure density was large for high elevations (>700 m) and positive curvature (convex shape) and also increased with increasing slope. These results suggest that slope failures are more likely to occur at slopes that are more unstable when affected by intense shaking, as shown in previous studies (e.g., Nishida *et al.*, 1996).
