Difference in Deterioration Rates Based on Location in Wooden Crib Dams

Quoc D. DANG^{1*}, Yoshiharu ISHIKAWA² and Marie OGAWA³

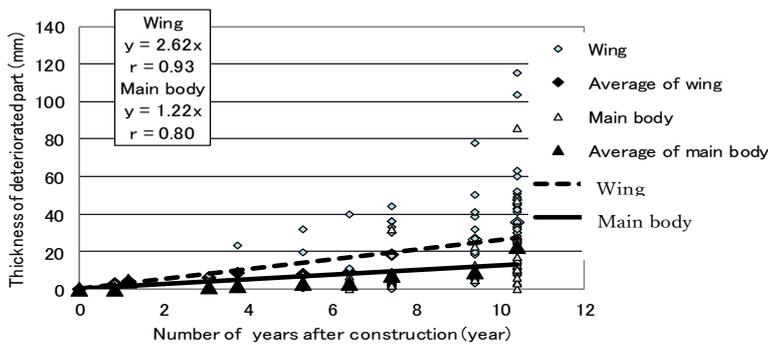
Yearly change in the thickness of deteriorated parts of Keihokucho 2 dam is shown in **Figure 1**, where the locations above and below the dam spillway are indicated as wing and main body, respectively. The thickness of the deteriorated parts of the other three dams also increased at a constant rate as the number of years after dam establishment increased. Hence, there is no sudden change in deterioration rates of wooden crib dams over time. In addition, the dispersion of the deterioration rates in a single dam were significantly wide. The deterioration rates of the wing were higher than those of the main body in Keihokucho 1 and 2 dams, both of which have running water during normal times. On the other hand, the difference in deterioration rates between the wing and main body was minimal when data from Kuta and Ooe dams where there is almost no running water during the normal period of time were compared.

Fig. 1 The relationship between the number of years after establishment and the thickness of deteriorate part of Keihokucho 2 dam

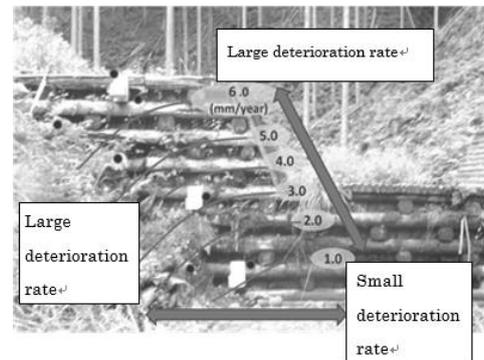
Deterioration rates of each part of the Keihokucho 2 dam are shown in **Figure 2**. Deterioration rates are largely different depending on where the wood is located even within a single dam. Wooden parts located near running water (spillway, right under the spillway, and dam base) during normal conditions tend to have lower deterioration rates and the longer the distance from those locations, the higher the deterioration rates tend to become. The distributions of the deterioration rates of other three dams were similar to those of the Keihokucho 2 dam.

Fig. 2 Distribution of main deterioration rates which represent each part of Keihokucho 2 dam

The average deterioration rates of wooden crib dams do not change over time. On the other hand, the longer the distance from where the running water exist, the higher the deterioration rates are. During the design of a wooden crib dam, the difference in the degree of deterioration based on the location of the wooden parts in the dam should be considered. It is also important to consider the difference in the deterioration rates based on location and investigate different parts of the dam during inspection.
