Measures to Reinforce the Left Bank Part of the Shiraiwa Sabo Dam

Ryoichi MICHIHATA^{1*}, Keiji MUKAI¹ and Takeshi OSAKA²

¹ SABO and LANDSLIDE TECHNICAL CENTER, Japan

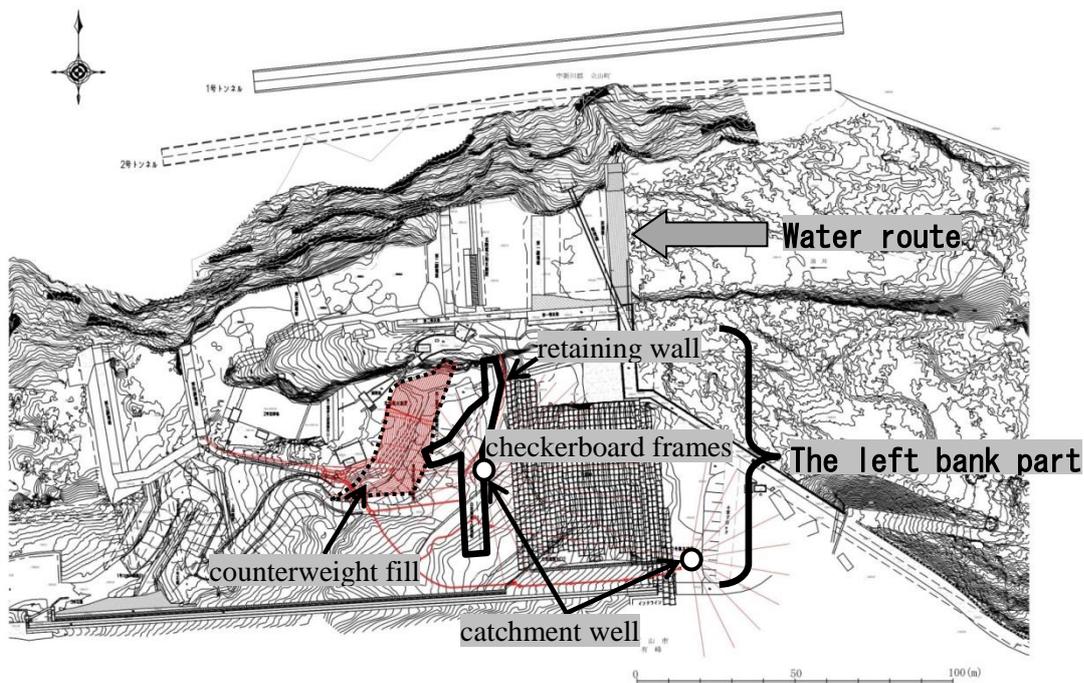
There was no deformation of the left bank part of the Shiraiwa Sabo Dam after the completion for a long term, and stability was kept. But from about 1988, when approximately 50 years passed after construction, examination of the reinforcement by the deterioration was started. In the examination, spring point investigation, groundwater level observations, and water quality tests were carried out. It was grasped that the groundwater of the left bank part were mixed by that derived from the mountain slope beside the left bank part and the penetration water from the river of upper reaches, and its mixture ratio of each spot. Based on these examination, the counterweight fill and two water catchment wells were constructed as the facilities which plans to keep the long-term stability of the left bank part by 2009 (cf. **Figure 1**). Also the boring

Fig. 1 The Shiraiwa Sabo Dam and the left bank part

direction of the water catchment well was decided to cover a wide area and depth to remove the groundwater from mountain slope beside the left bank part as well as the groundwater from the river direction.
