Landslide Dams Caused by the M7.8 Kaikoura Earthquake

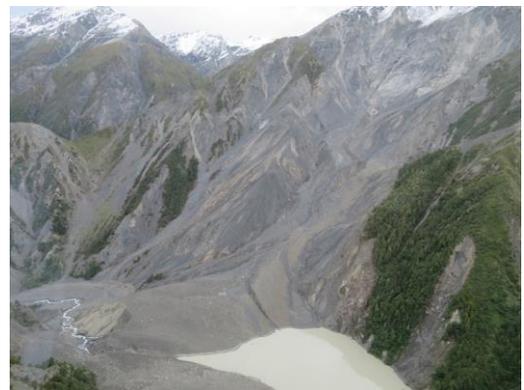
The landslide dam on the Hapuku River (**Fig. 1**) was the highest (about 150 m high) of the dams triggered by the M7.8 Kaikoura earthquake and covered an estimated 656,430 m², with 12,000,000 m³ of collapsed rock (Rosser, 2017). The landslide was a rock avalanche. The bedrock geology of the watershed is dominated by greywacke (a variety of sandstone). Numerous shallow landslides also occurred along the Hapuku River. The main dam crest, which was monitored by a live camera installed by Kaikoura District Council, overtopped on 6 April 2017, after which the water level of the lake behind the dam decreased rapidly, although it did not empty. Rapid increases in flow depth due to the overtopping were observed about 11 km downstream from the dam, at State Highway 1, on a water level recorder installed and operated by NZTA.

Fig. 1 Landslide dam on the Hapuku River
