Characteristics Sediment Disaster in the Tottabetsu River, Hokkaido Prefecture, Caused by the Heavy Rainfall in August 2016

Toshihiko YOSHIMURA¹, Takashi ISHII^{1*} and Masahide MATSUZAWA¹

1 Flood Control Section, Construction Department, Hokkaido Regional Development Bureau, Ministry of Land, Infrastructure, Transport and Tourism, Japan

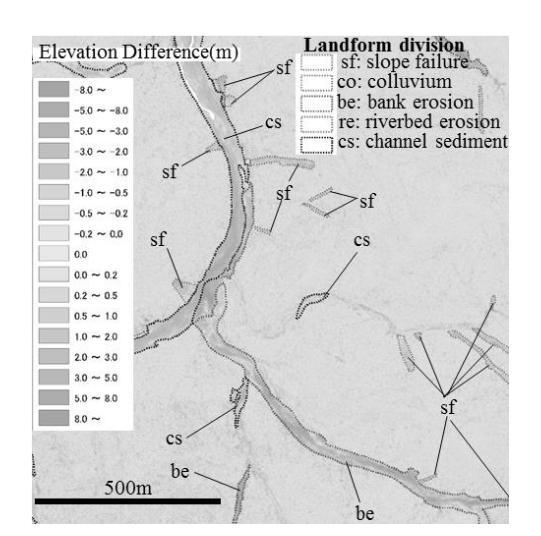
The breadth of the river has widened in some section of the alluvial fan area, based on comparing the aerial photography of 2013 and 2016 (**Fig.2**).

Fig. 2 Heavy rainfall in August 2016 widened river channel in alluvial fan

We consider bank erosions occurred in alluvial fan. We must consider preventing not only riverbed scour but also bank erosion in alluvial fan. We want to find out the efficient site and condition. We will continue to survey on field. In alluvial fan, we have no standard of inhibiting sediment generation. We must try to reveal the characteristics of the sediment disaster.
