Ex. 1 Earthquake, Sediment Disaster, and Historical Sabo Course

1. Overview of the Inspection Course

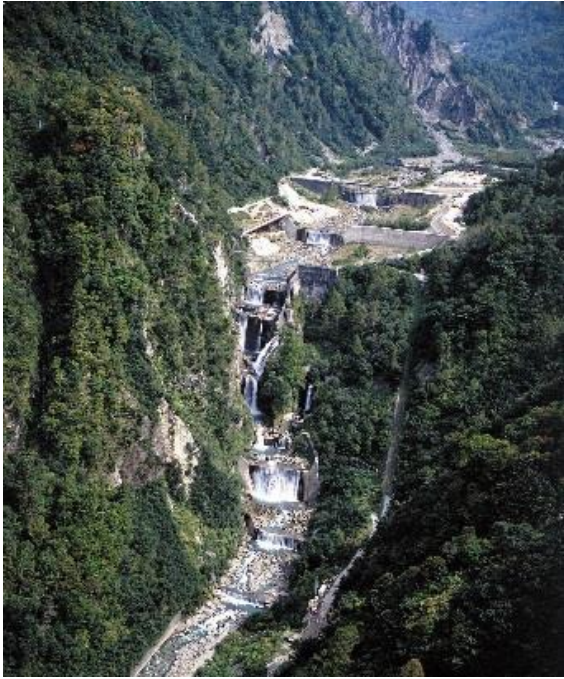
Shiraiwa Sabo Dam;
Nationally designated
important cultural properties

- Shiraiwa Sabo Dam: One of Japan's greatest sabo dams. Its total head including the main dam and auxiliary dam is 108 m, the largest in the country. It is also the first sabo facility to be designated as a national important cultural property.

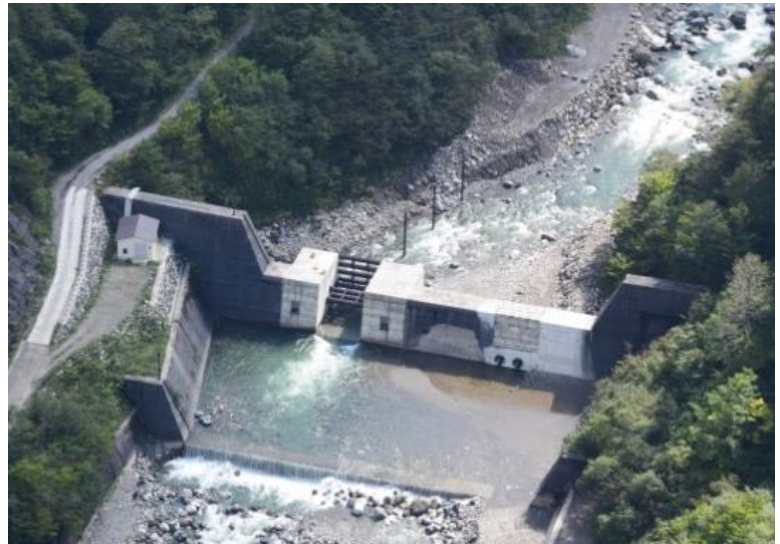
Myo-Jyu Sabo Dam
with movable “shutter”
Gate SABO Dam

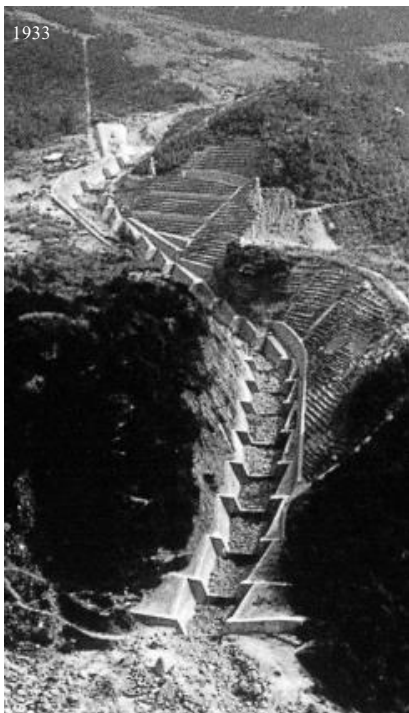
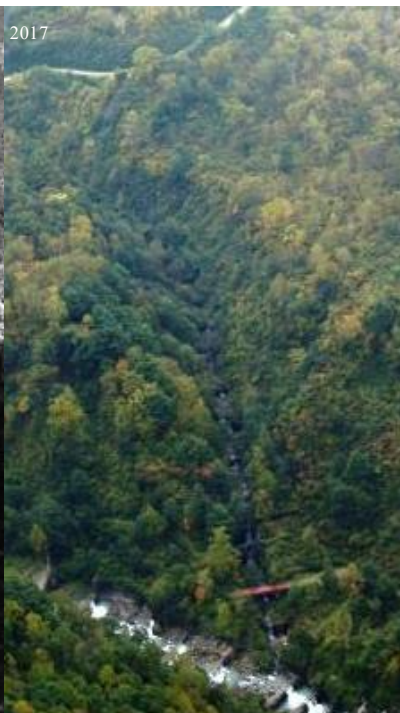
Dorodani Sabo Dam Group
Revitalizing the Greens

- Dorotani Sabo Dams: These sabo facilities are structures with stepped dams constructed in series, which prevents the erosion of collapsed soil or the expansion of collapse, and effective in promoting mountainside greening. They were designated as a national important cultural property in 2017.
