# Analysis and Reconstructed Modeling of the Debris Flow Events on the 29<sup>th</sup> of August and the 4<sup>th</sup> of September 2016 of Afritz (Carinthia, Austria)

Claudia SAUERMOSER<sup>1\*</sup>, Markus MOSER<sup>2</sup> and Susanne MEHLHORN<sup>2</sup>

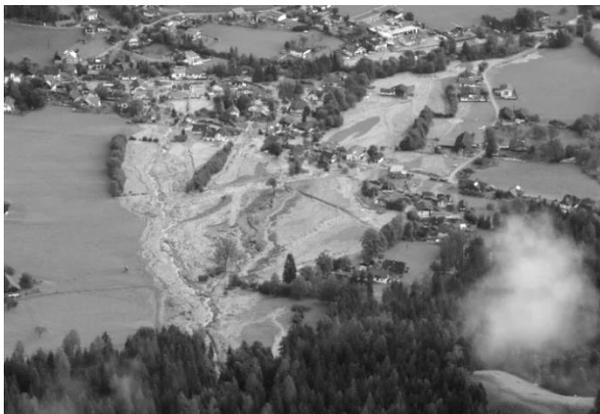
**Figure 1** deposition area of the second debris flow on the 4<sup>th</sup> of September 2016 (©WLV)

Within one week, precisely on the 4<sup>th</sup> of September, the second debris flow occurred at about 14:00 UTC. Due to the open banks caused by the first debris flow, around the same amount of debris was mobilized and transported down to the debris cone. The dominant process type of the second mass movement event was a more fine-grained flow than the first one. However, because of early warning, the settlement was already evacuated. In total, 45 buildings were damaged along the Tronitzer torrent.
