Emergency Responses to Debris Flow Disaster at Serizawa, Nikko-city Triggered by the 2015 Torrential Rains in the Kanto and Tohoku Region

Kenji MIWA^{1*} and Kenji TAKETOSHI¹

¹ Nikko Sabo Office, Kanto Regional Development Bureau, Ministry of Land, Infrastructure, Transport and Tourism

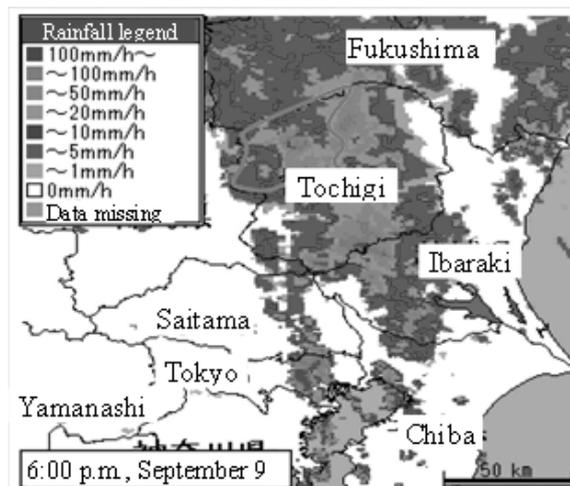
Fig. 1 Radar rainfall (00:00 a.m., September 10, 2015)

As seen in **Fig. 1**, the record rainfall was caused by multiple occurrences of linear precipitation bands that formed between September 9 to 11. In particular, the total rainfall ranged between 500 and 600 millimeters, in Nikko-shi, Tochigi, located upstream in the Kinugawa River Basin. As a result, into predawn hours of September 10, several debris flows were triggered in eight separate mountain streams in the Serizawa area (see **Fig. 2**). Traffic on the municipal road was cut off and six houses were completely or partially destroyed. Despite this, there were few human casualties with only two inhabitants injured.

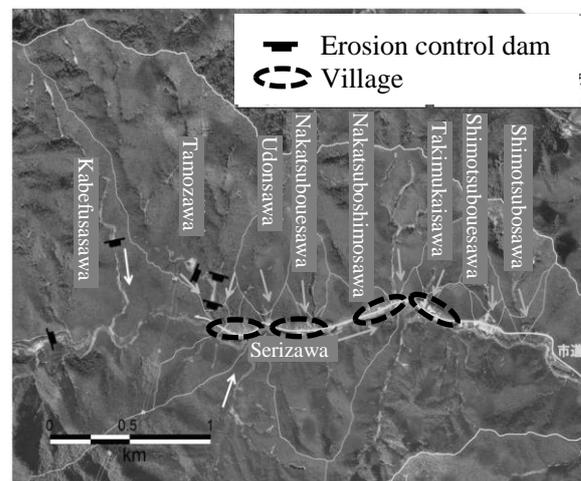
Fig. 2 Debrisflows map of Serizawa

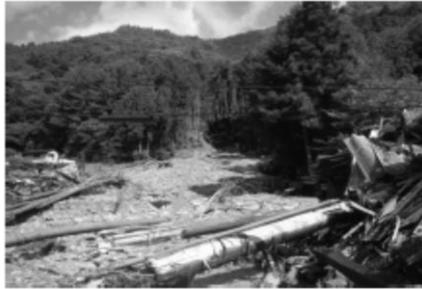
Photo 1 Erosion of Nakatsubouesawa Stream

In each mountain stream, traces of sediment yield (from slope failure, vertical erosion, gully erosion, river bank failure, etc.) were identified. by an analysis of the difference between the aeronautical laser surveys of. 2012and2015. It is believed that the debris flow resulted when rising stream water combined with fed-in sediment (**Photo 1**).

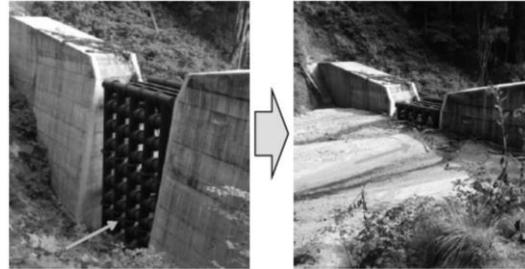
Photo 2 Effect of erosion control facility
(Tamozaawa Erosion Control Dam 1)

Debris flows also occurred in Tamozaawa. Three check dams install there, which caught and controlled the sediment and driftwood and prevented the damage from extending to the village located below (**Photo 2**).

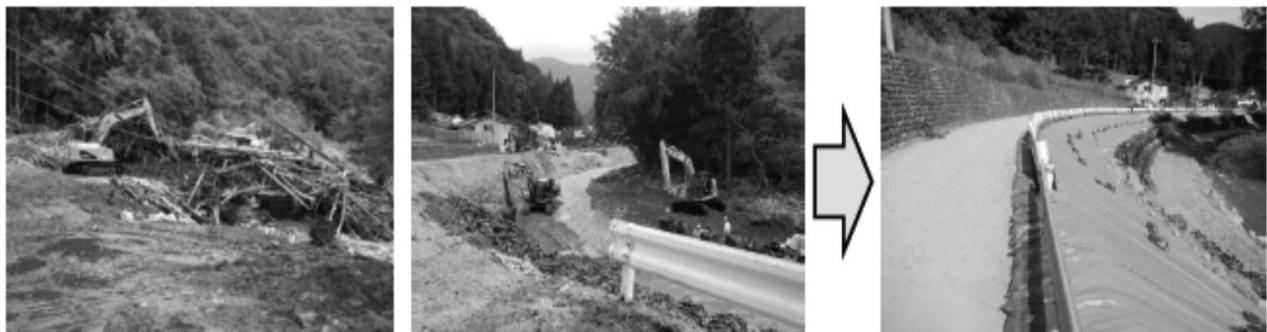
(a) Temporary restoration work underway

(b) Road temporarily restored

Photo 3 Removing debris from the road

Since heavy equipment was available due to construction of an check dam in Serizawa's Udonsawa stream, it was used to quickly clear the municipal road cut off by debris, and temporarily restore the section washed away by rising waters. This made it possible to reopen the road by September 20 (**Photo 3**).
