Characteristics of Sediment Discharge in the Tokachi Region, Hokkaido, due to Continuous 4 Typhoons in August, 2016

Nobutomo OSANAI¹, Mio KASAI¹ Shin-ichiro HAYASHI^{1*}, Shin'ya KATSURA¹
and Takahisa FURUICHI¹

¹ Research Faculty of Agriculture, Hokkaido University, Japan

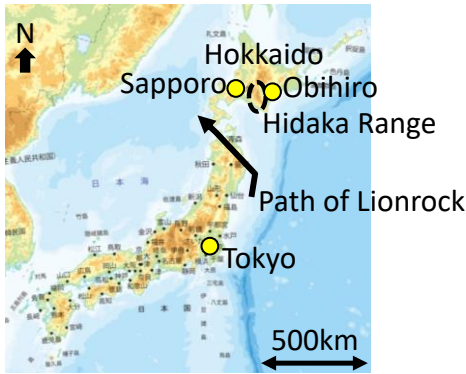
Fig. 1 The study area and the path of Lionrock

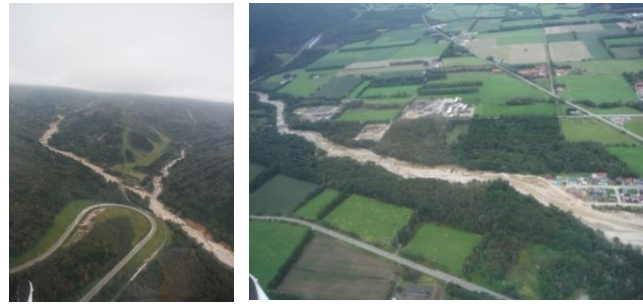
Fig. 2 The sediment discharge in the Pekerebetsu River (Left: debris flow at upper stream, Right: bank erosion and flooding at in the center of Shimizu town, 2016/9/12)

The sites of sediment discharge happened (e.g., Totsutabetsu, with a total precipitation of 530 mm, and Nissho, with 367 mm) coincided not with the heaviest precipitation (e.g., Notsuka, with 713 mm), but with granite geology. From the Panke-Shintoku River to the Totsutabetsu River on the eastern slopes of the Hidaka Range, 9 branch streams of the Tokachi River discharged huge volumes of sediment caused by debris flows. In particular, the Pekerebetsu River discharged at least 0.63 million m³ of sediment, the first such discharge in approximately 50 years. As a result, bank erosion and flooding caused by aggradation of the river bed and blockage at bridges due to sediment and drift wood, inundated in approximately 160 ha, washed away 10 houses in the center of Shimizu Town. The sediment was mainly composed by granite boulders and fine materials which came from gently sloping periglacial terrain. (**Fig. 2**, Osanai *et al.*, 2017)

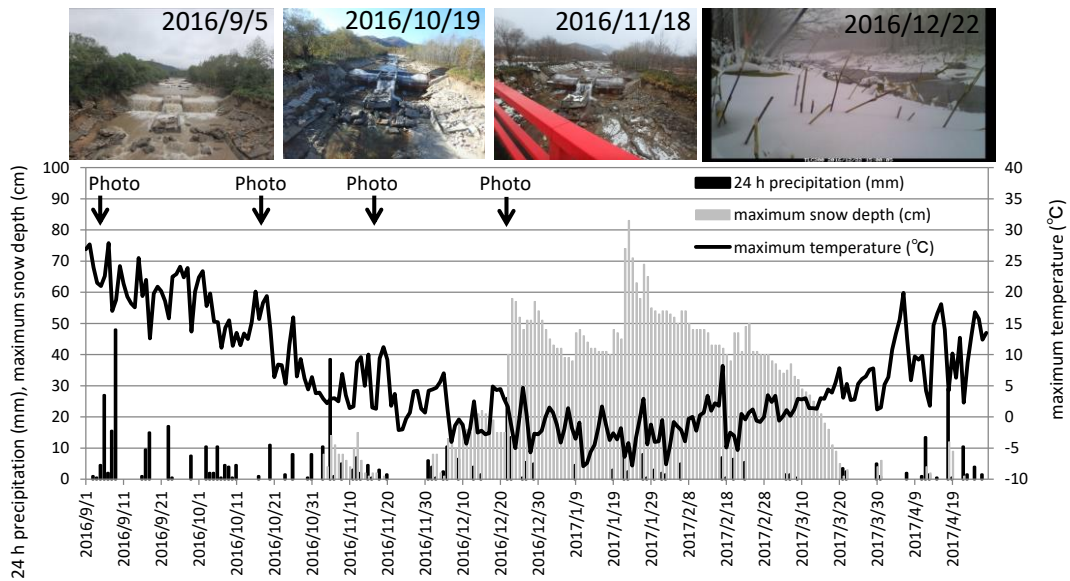
Fig. 3 24 h precipitation, maximum snow depth, maximum temperature at Shintoku and photos of a main stream at the Pekerebetsu River around No. 13 groundsill

At the Pekerebetsu River, we kept monitoring in the main stream since sediment discharge happened. **Fig. 3** shows 24 h precipitation, maximum snow depth and maximum temperature at the Shintoku AMeDAS station. Photos of a main stream at the Pekerebetsu River around No. 13 ground sill were taken by digital camera and Time lapse camera BrinnoTLC200. The photos show that the stream water had turbidity soon after sediment discharge happened (September 5). But, turbidity of the stream water disappeared one month later (October 19). Then, ground survey indicate that, as of April, 2017, water discharge did not change widely and it is continuing less turbidity even during the snowmelt season.
