Maintenance of Historical Sabo Facilities by the Tateyama Sabo Office

- Evaluation of the Soundness and Utility of Sabo Facilities -

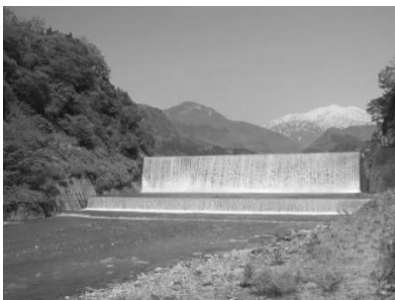
Fig. 1 Hongu Sabo Dam

The Hongu Sabo Dam is a large check dam that was constructed in the middle reach of the Joganji River, one of the steepest rivers in Japan (The average bed slope is about 1/30). The dam is 22.0 m high, has a crest length of 107.0 m, a volume of 37,000 m³, and a sediment trap capacity of 5million m³, the largest in Japan. In recent years, improvements have been made to enhance the environment around the Hongu Sabo Dam, which was made in the days before mechanized equipment. To save cement, the front and crest of the dam were made of stone, and rubble concrete was used inside the dam (**Fig.2**). The construction of the Hongu Sabo Dam required large tower cranes and chutes, and rubble concrete, which were state-of-the-art equipment, materials, and methods of the time (**Fig.3**). Despite its size, the dam was completed in less than 2 years.

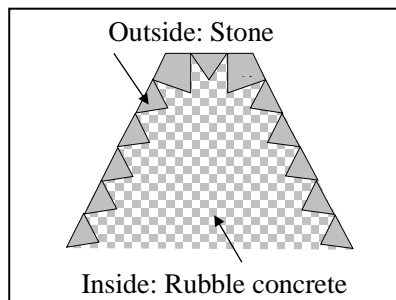
Fig. 2 Rubble concrete dam

The rubble concrete inside a rubble concrete dam may be of poorer quality and weaker than modern ready-mixed concrete although, if the outer material (stone, etc.) is not damaged, the dam

will not fail catastrophically. In other words, the soundness of rubble concrete dams depends largely on the state of the outer materials (stone, etc.).

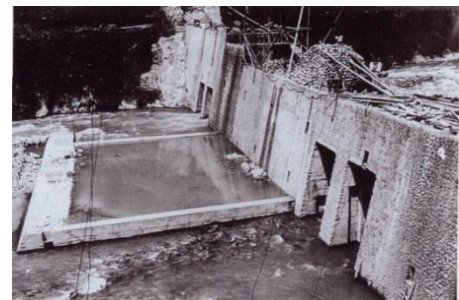
Fig. 3 Under construction
