Study of Sediment Yield Characteristics in Cold Dry Area by Satellite Image Armenian Case Study of Sediment Control Using Japanese Method

ARMENIAN CASE STUDY

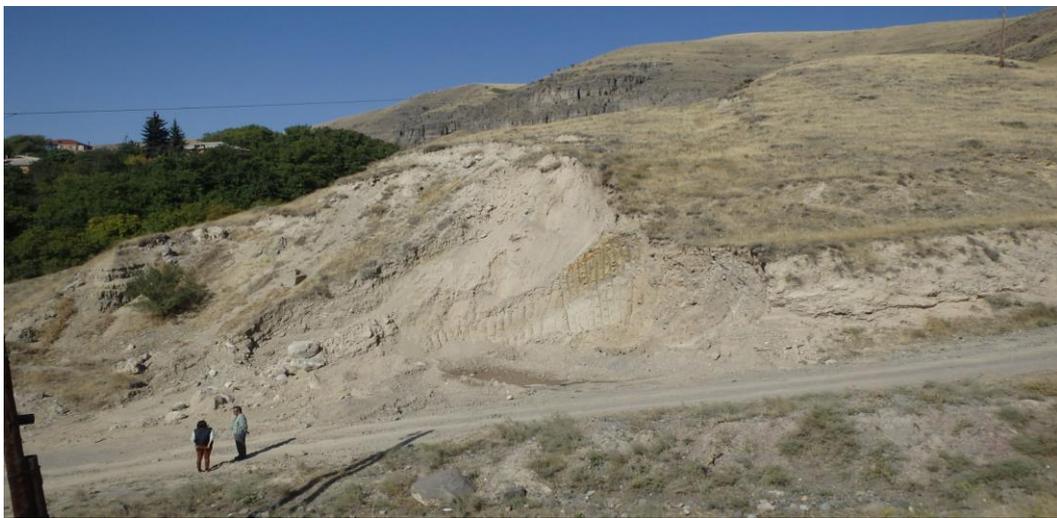
Photo 1 Characteristics of vegetation on the land surface of Armenia.

Armenia has a dry climate compared with Japan, and its vegetation is unevenly distributed in the valley which is rich in groundwater.

In this study, the characteristics of sediment yield were analyzed using satellite technology. Armenian land surface has almost dry environment and the vegetation is unevenly distributed according to geology and soil.

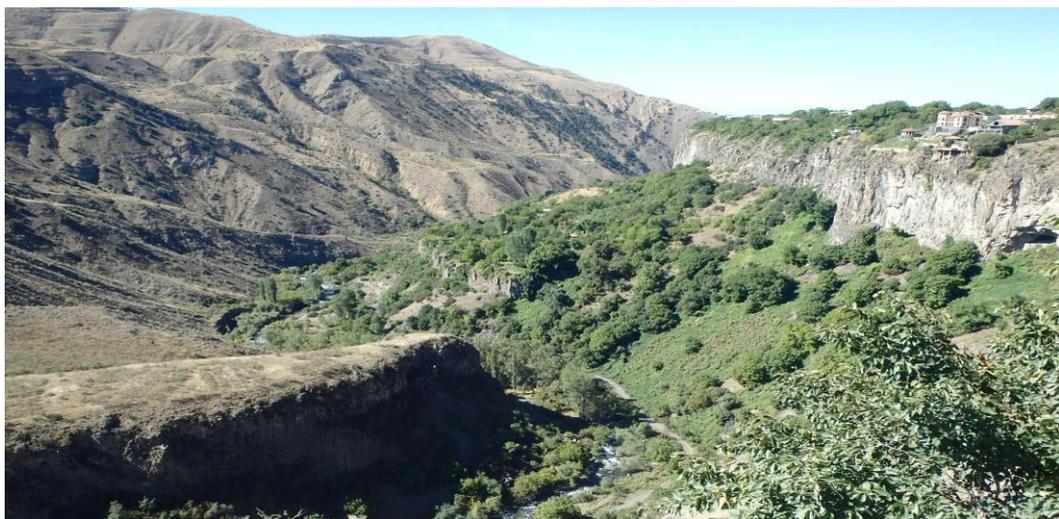
Photo 2 Characteristics of river area topography. At this world, natural heritage site called "Garni Gorge", there is lack of development at the bottom valley plain and there is a large amount of sediment due to riverbank failure. There are many plants on the south facing detritus deposit.
